NASA TM X-2461

HYDROGEN PLASMA TESTS  
OF SOME INSULATING COATING SYSTEMS  
FOR THE NUCLEAR ROCKET THRUST CHAMBER

*by Arthur N. Curren, Salvatore J. Grisaffe,  
and Kurt C. Wycoff*

*Lewis Research Center  
Cleveland, Ohio 44135*

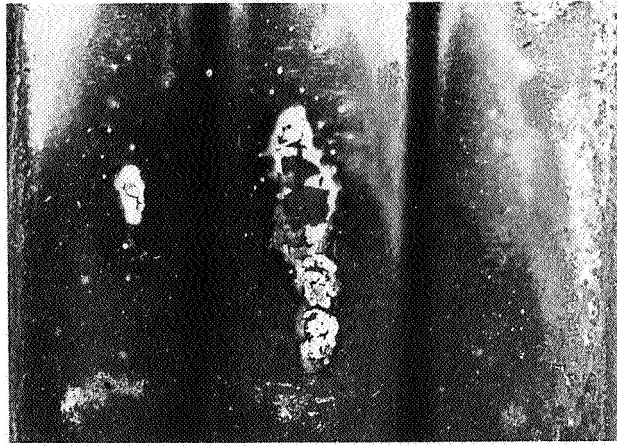
(a) Face view of coating system sample after step testing to  $9.8 \times 10^6$  watts/meter<sup>2</sup> (6 Btu/(in.<sup>2</sup>)(sec)). Original photograph, X3.

(b) Section view of untested coating system. Original photomicrograph, X250.

(c) Section view of coating system step tested to  $9.8 \times 10^6$  watts/meter<sup>2</sup> (6 Btu/(in.<sup>2</sup>)(sec)). Original photomicrograph, X250.

Figure 12. - Coating system surface and structure changes of sample 4:E (Mo sublayer/nichrome middle layer/ $Al_2O_3$  outer layer) resulting from hydrogen plasma testing.

Figure 12 shows a summary of the history of one slurry/cure coating, system 4:E. The specimen surface was blistered after the step testing to  $9.8 \times 10^6$  watts/meter<sup>2</sup> (6 Btu/(in.<sup>2</sup>)(sec)), as shown in figure 12(a). Figures 12(b) and (c) show the untested and the tested zones, respectively, after this exposure. While good metal-oxide grading is observed in the interior layers, no continuous metal underlayers ( $0.051 \times 10^{-3}$ -m (0.002-in.) Mo,  $0.076 \times 10^{-3}$ -m (0.003-in.) nichrome) can be seen. The coating process may require some oxide material to react with an active (possibly phosphate) bonding agent and may thus not be capable of depositing metal layers. Approximately 70 percent of this coating was lost during exposure.
